Final report RL 2014:07e

Serious incident at Sveg Airport on May 3, 2013 involving aircraft ES-PJR of the model Jetstream 3200, operated by AS Avies.

File number L-46/13

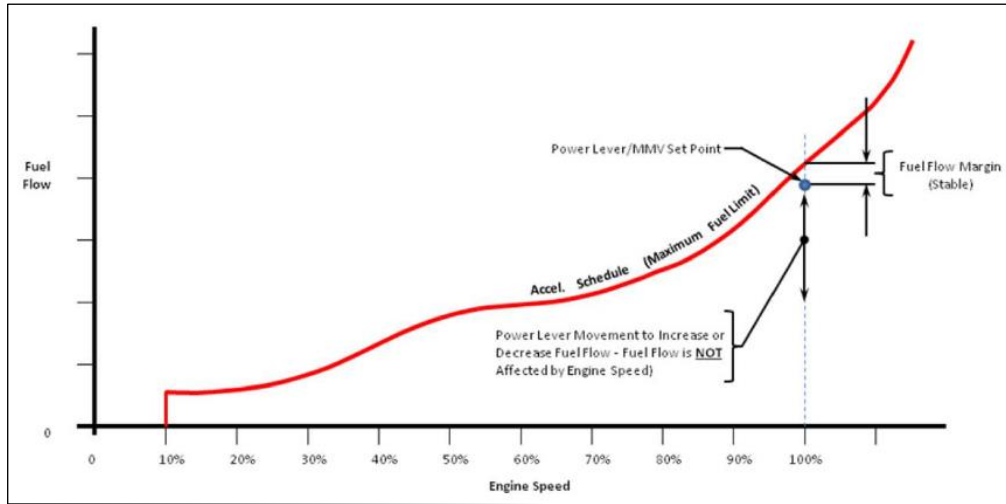
Figure 18. Stable operating mode. Photo: Honeywell.

It was then clear that an imbalance can occur between the FCU and the Propeller Governor if the RPM is not sufficiently high when a high engine power is set. The results may include severe oscillations in RPM and the propeller setting and thereby in the engine's thrust (Tq).

As mentioned in section 1.6.9, the acceleration schedule allows a certain maximum fuel flow (FF) to the engine during acceleration at a given engine RPM. Under normal operating conditions, with the engine stable at a constant RPM, the FF is set by the Main Metering Valve (MMV) via the Power Lever. At 100% RPM there is a margin between the FF demanded by the Power Lever schedule and the maximum FF limit available from the acceleration schedule (the vertical dashed line at 100% RPM in Figure 18 below). The engine is operating in a stable mode in terms of engine power.
